Hensley Field

Building Assessment

Buildings 1 - 6

Hensley Field Building Assessment
 Dallas, Texas

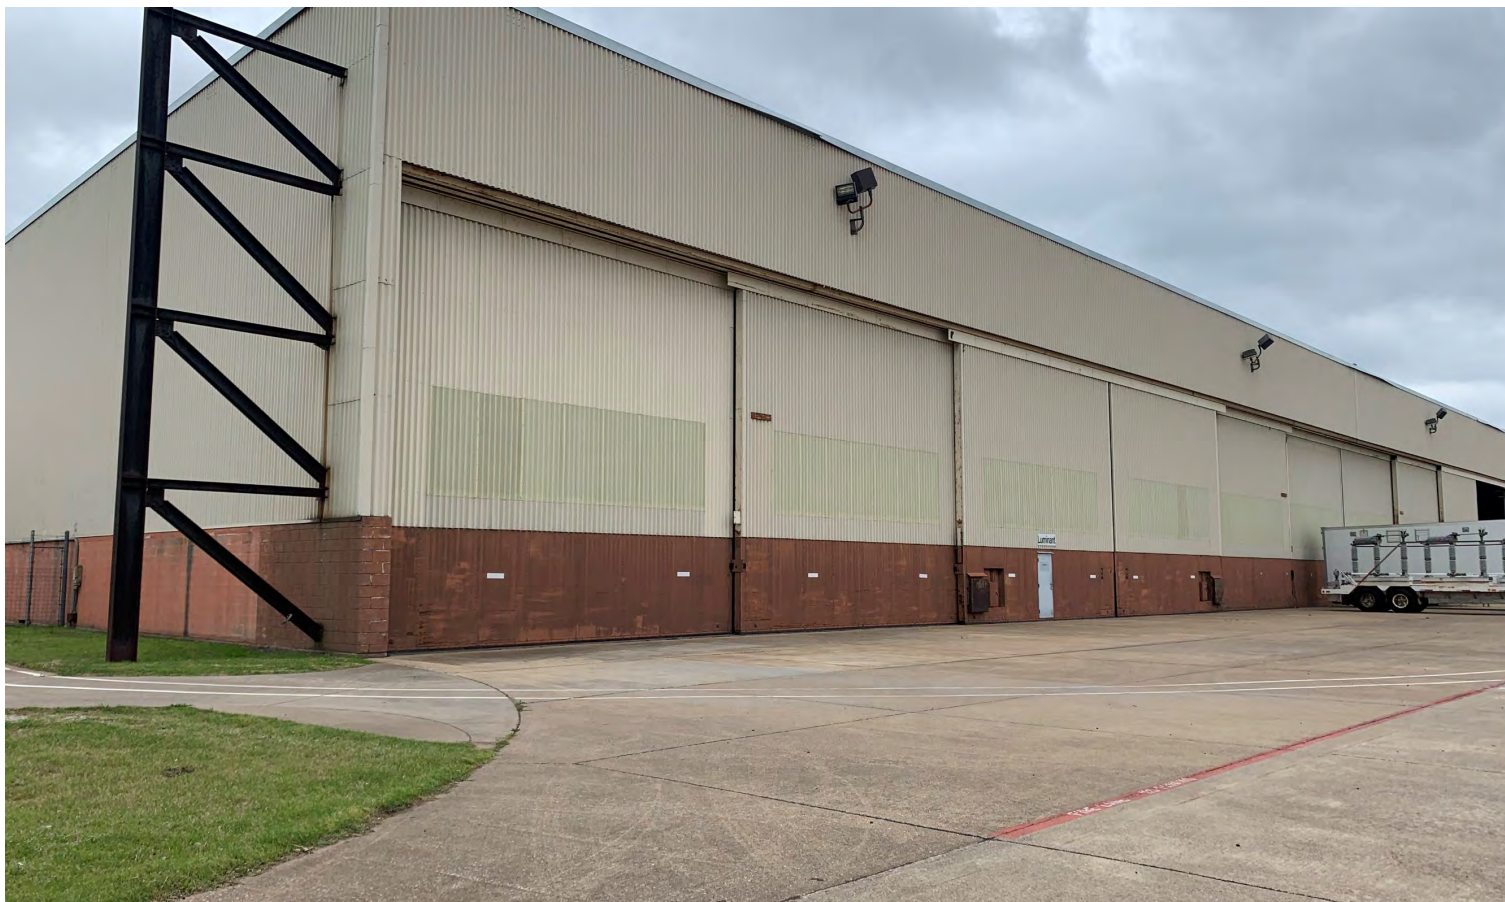
BLDG 2 AIRCRAFT MAINTENANCE HANGAR

Building Dimensions: 145' x 408' +/-
Building Area: 60,000 SF (1st) and 25,000 SF (2nd)
Building Grid: 24' x 20'
Clear space Height: 24'

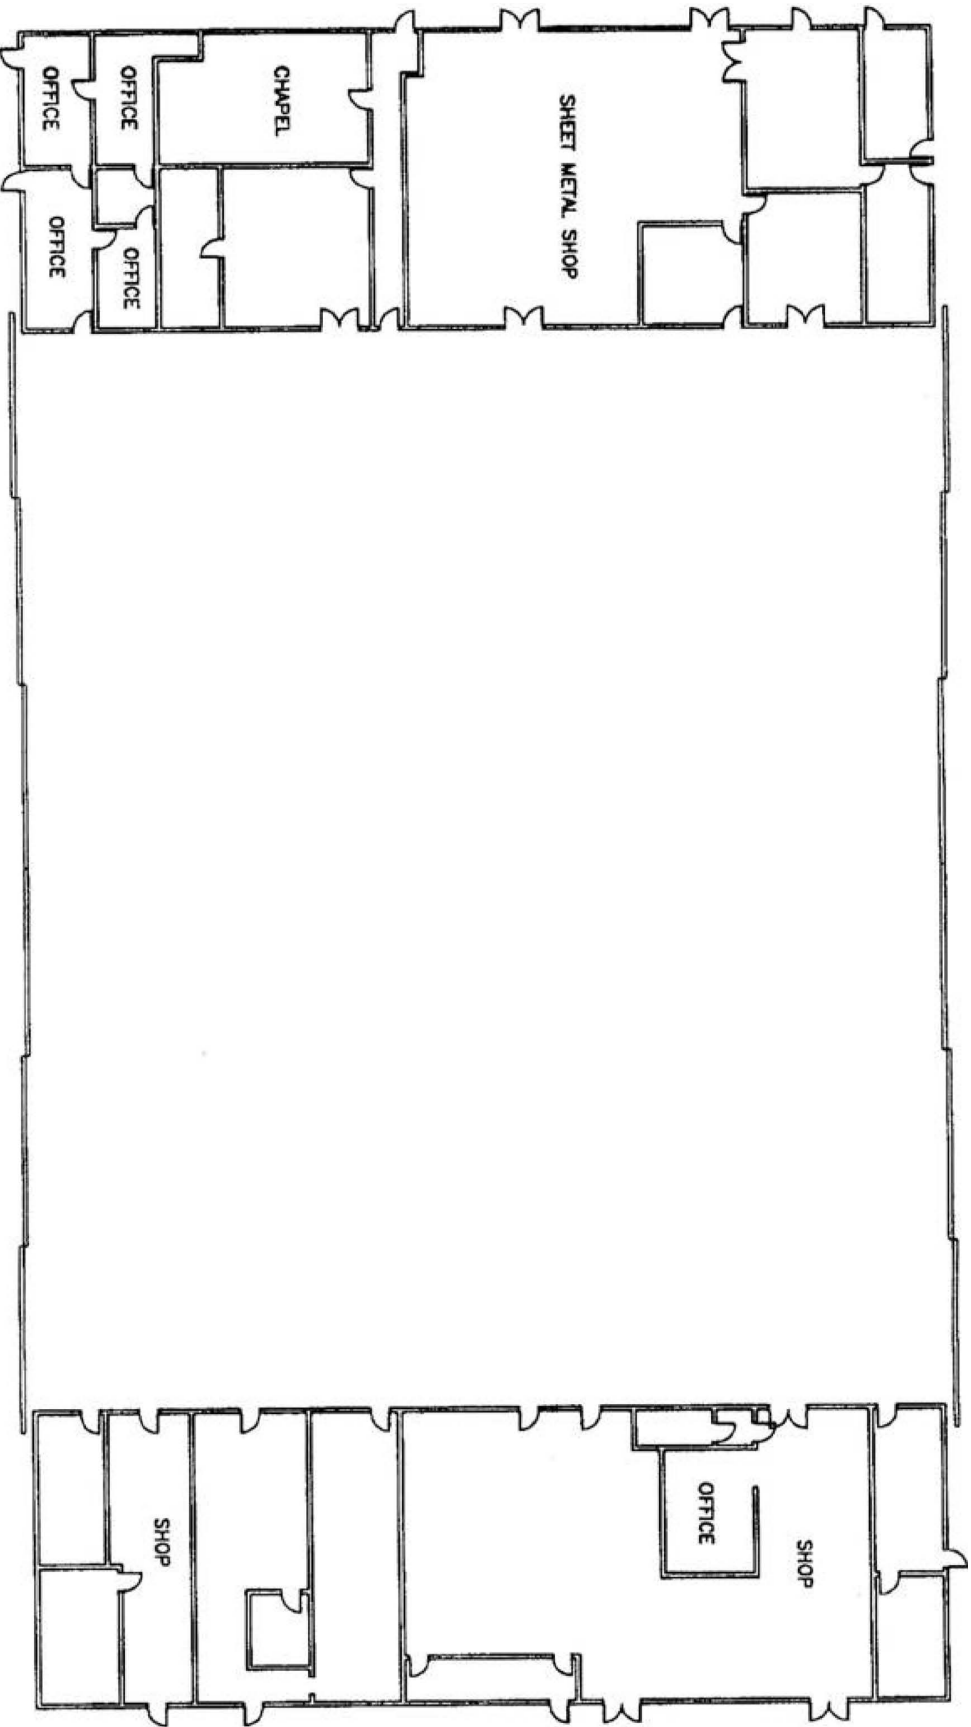
Building Dimensions: 230' x 128' +/-
Building Area: 30,300 SF (1st) and 12,000 SF (2nd)
Building Grid: 28'
Clear space Height: 35'
70,300 SF

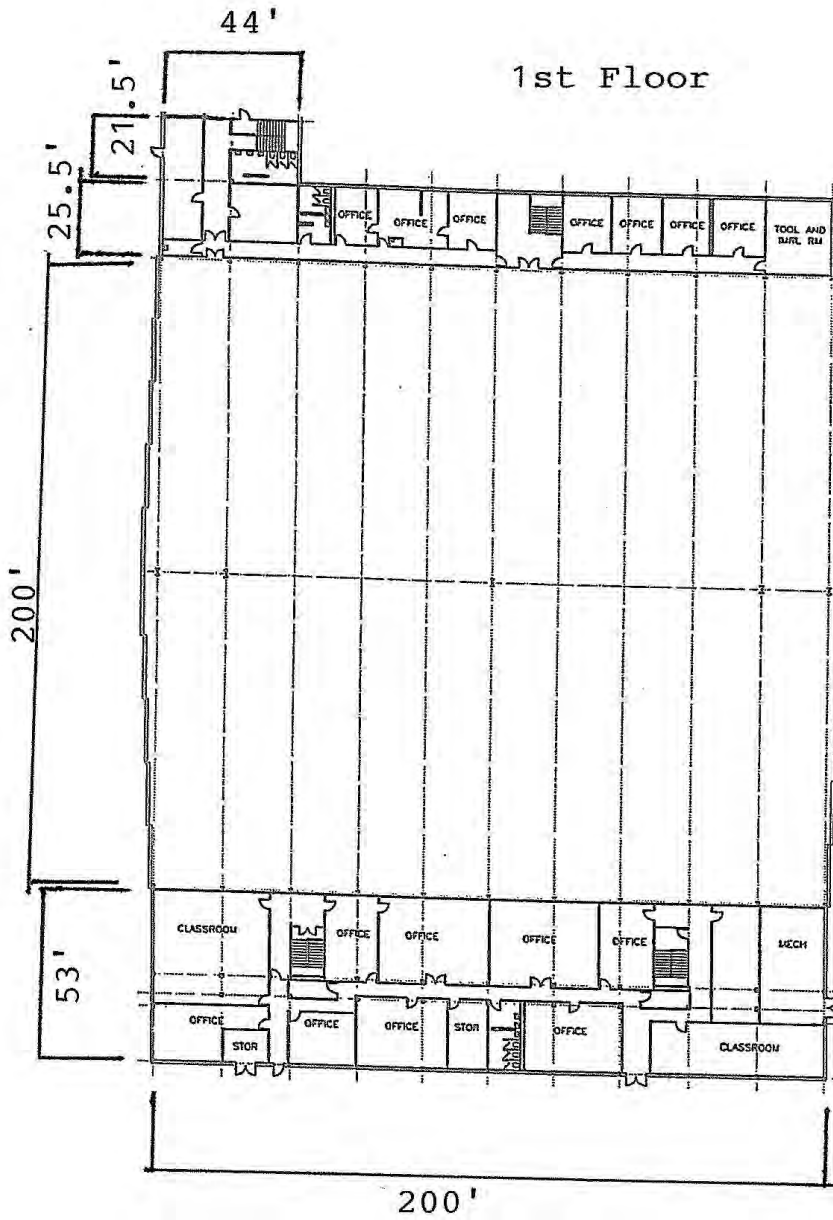
Building Dimensions: 270' x 200' +/-
Building Area: 54,000 SF (1st) and 10,000 SF (2nd)
Building Grid: 28'
Clear space Height: 35'
